NATIONAL ADVISORY COMMITTEE FOR AERONAUTICS

THE EFFECT OF LIQUID AND ICE PARTICLES ON THE
EROSION OF A SUPERCHARGER-INLET COVER

AND DIFFUSER VANES

NACA MR No. E6E31

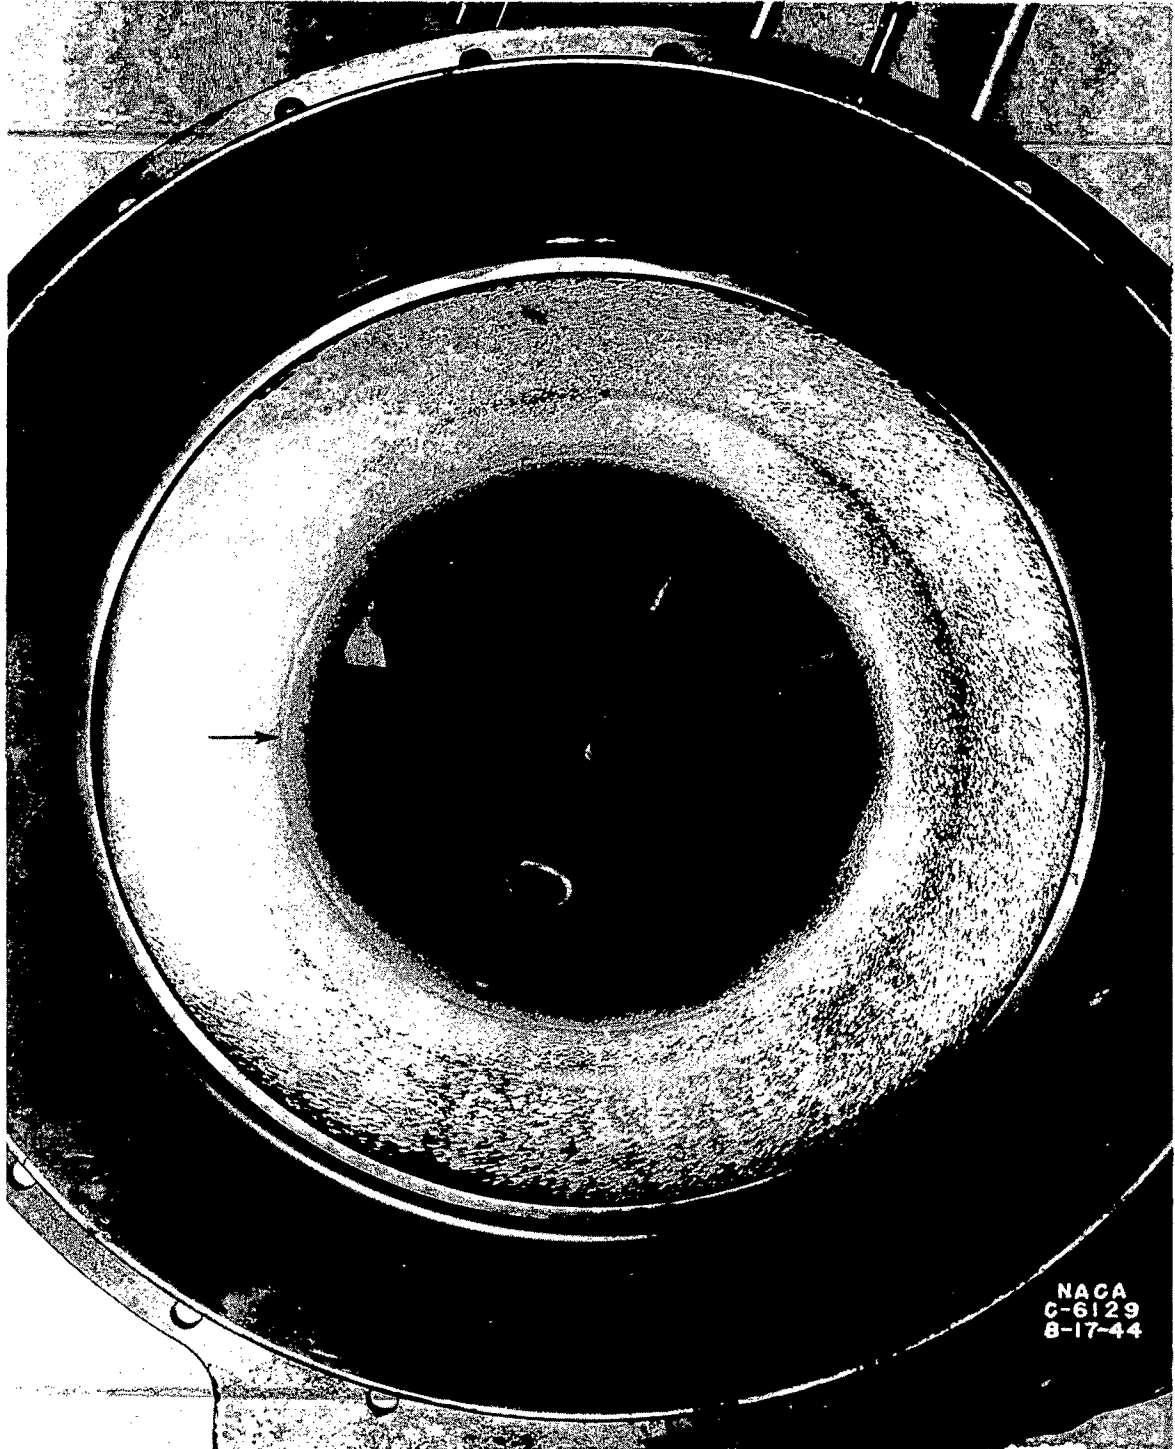
During an overhaul of the setup used for the icing investigations described in references 1 and 3, the inner surface of the supercharger-inlet cover in close proximity to the impeller was observed to be badly eroded. Erosion reached a depth of approximately 0.030 inch and was much worse on the left side than on the right side of the inlet cover, as seen in figure 1(a). The deeper annular depression noted by the arrow was located just opposite the point where the steel inducer joins the aluminum impeller. The

erosion was more uniform on the portion of the cover shown at the left of the photograph; ice that formed in the bottom of the elbow would first strike this area when loosened during the de-icing process because the supercharger impeller rotated in a clockwise direction as viewed from the front of the engine. The leading edges of two of the six diffuser vanes are shown in figure 1(b). Erosion removed about three-eighths inch of metal from the leading-edge portion of the diffuser vane near the curved surface of the cover.

Consideration of the seriousness of this problem prompted a survey of the running time and test conditions for the setup. It was found that the total running time for this setup prior to inspection had been 861 hours, which included 110 hours operation with rain ingestion simulated by spraying water into the air stream about $6\frac{1}{2}$ feet above the carburetor top deck at an average rate of 46.3 pounds per hour. During the determination of icing characteristics, $8\frac{1}{4}$ hours of the running time had been at simulated operation with water injection in the inlet elbow by means of a special nozzle large enough to accommodate the combined volume of fuel and water. These runs were made at air flows simulating take-off power with an average rate of water injection corresponding to a water-fuel ratio of 0.4. The amount of the observed erosion caused by passage of ice through the supercharger could not be determined.

(a) Surface erosion at entrance to impeller.

Figure 1. - Effect of liquid and ice particles on erosion of supercharger-inlet cover resulting from 110 hours of operation under various icing conditions.

Erosion of the diffuser-vane leading edges may be prevented by use of an erosion-resistant metal. Elimination of the discontinuity where the steel inducer joins the rest of the supercharger would prevent grooving the cover at that point. A more durable corrosion-resistant surface would reduce inlet-cover erosion. Erosion caused by ice could be materially reduced by excluding water drops from the system before they reach the carburetor and by changing the method of fuel injection to prevent fuel-evaporation icing (reference 4). Erosion caused by water or water-alcohol injected with the fuel could be eliminated by injecting the water downstream of the supercharger. This factor may become increasingly important with extended use of water injection for increased power ratings of aircraft engines.

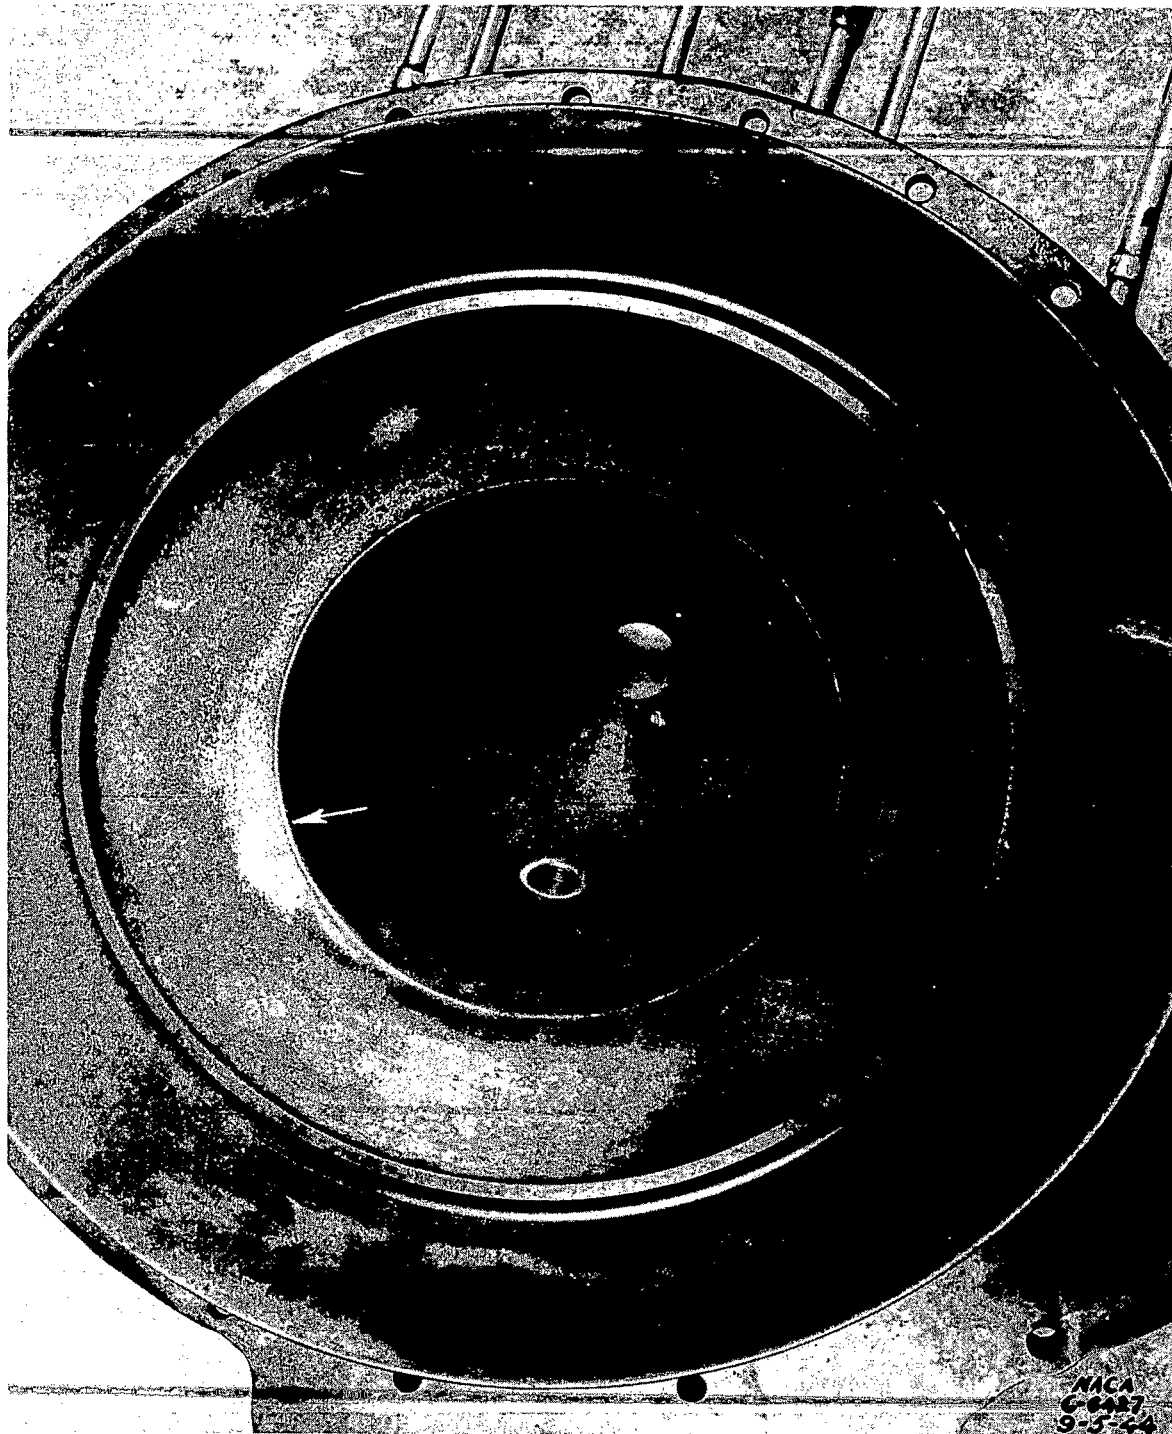
In the attempt to isolate the causes of erosion, the next two tests were made at take-off power conditions for $8\frac{1}{4}$ hours during which the liquid and air temperatures were maintained at about 75° F to prevent ice formation in the system. The erosion effect of liquid injected at a rate corresponding to a fuel-air ratio of 0.08 and a water-fuel ratio of 0.6 is shown in figure 2. The erosion effect of water alone on another inlet cover injected at a rate of approximately 485 pounds per hour for $8\frac{1}{4}$ hours is shown in figure 3.

(a) Surface erosion at impeller entrance.

Figure 2. - Erosion of supercharger-inlet cover caused by water and fuel injection. Rate of liquid injection, 1300 pounds per hour; duration of test, $8\frac{1}{4}$ hours.

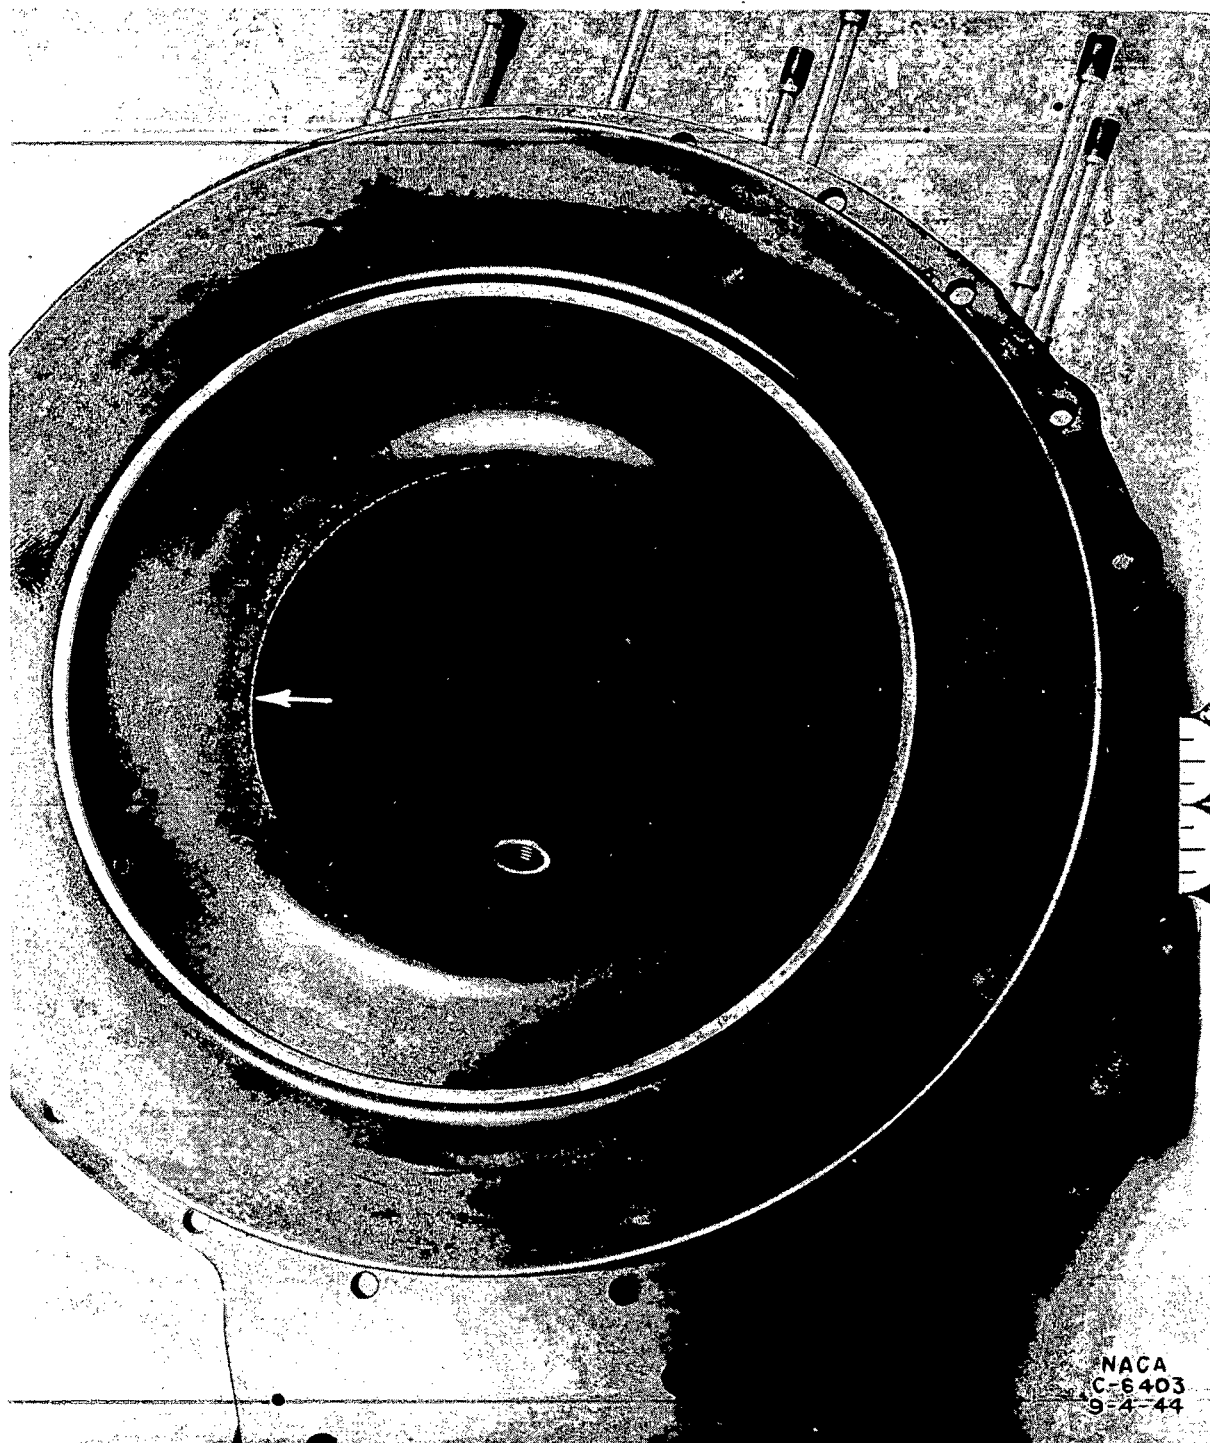
(a) Surface erosion at impeller entrance.

Figure 3. - Erosion of supercharger-inlet cover caused by water injection. Rate of water injection, 485 pounds per hour; duration of test, $8\frac{1}{4}$ hours.

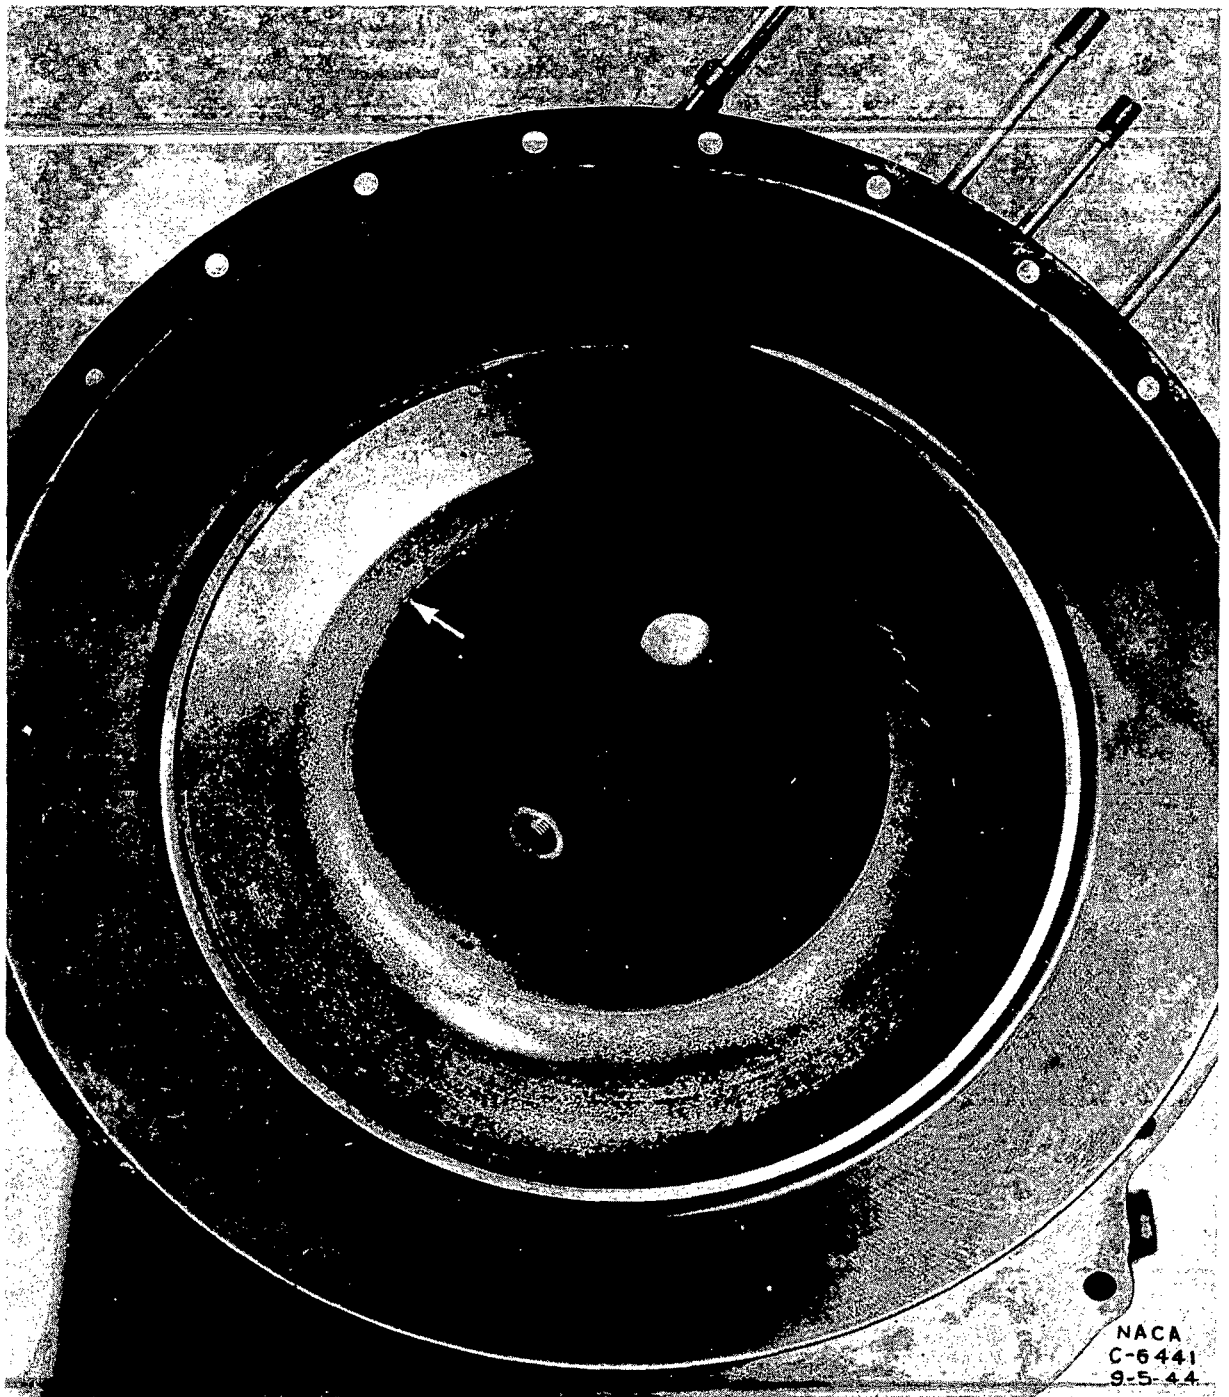
The results of the third accelerated erosion test of $8\frac{1}{4}$ -hour duration (fig. 4) indicate that the passage of ice through the supercharger caused most of the damage. In this case the inlet cover had been reconditioned after the mild erosion shown in figure 3. Ice, alternately formed and shed upstream of the supercharger at low carburetor-air temperatures, is apparently responsible for most of the erosion shown in figure 1.

(a) Surface erosion at entrance to impeller.

Figure 4. - Erosion of supercharger-inlet cover caused by water and fuel injection and ice particles. Rate of liquid injection, 1300 pounds per hour; duration of test, $8\frac{1}{4}$ hours.
